Catalyst Pluggage Reduction for Roxboro U3

- Matt Boone – Progress Energy
- Rob Mudry – Airflow Sciences

- November 17, 2009

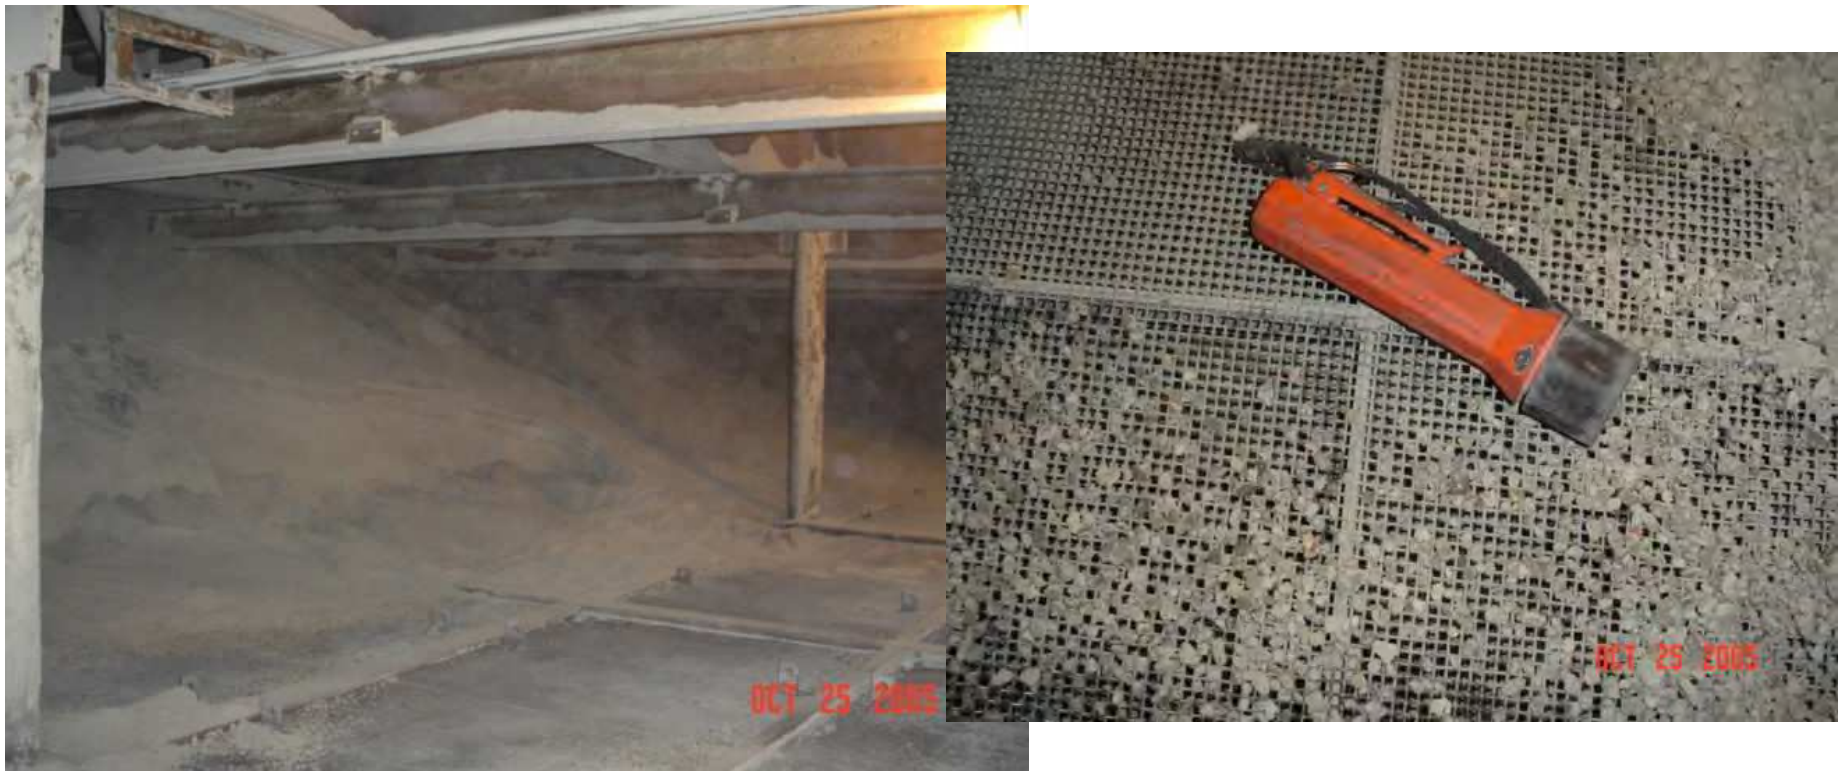
Problem Description – SCR

- Catalyst plugs with ash over time
- Large dunes (>4' high) over ~50% of both catalyst layers

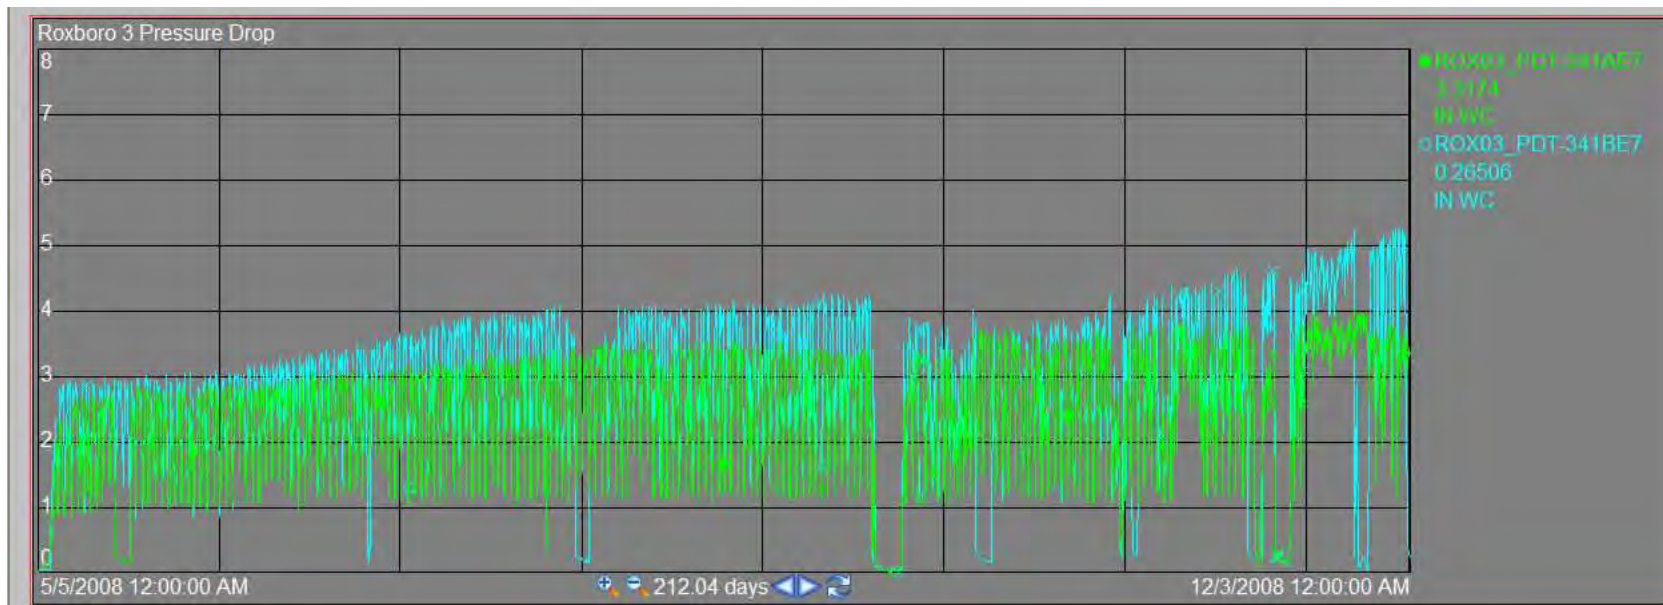
- Reactor pressure drop increases over time
- NH₃ usage increases as reactor pluggage advances
- NO_x reduction limited when NH₃ slip hits maximum

Reactor B DP: May 2008 (3 IWC) to December 2008 (5 IWC)

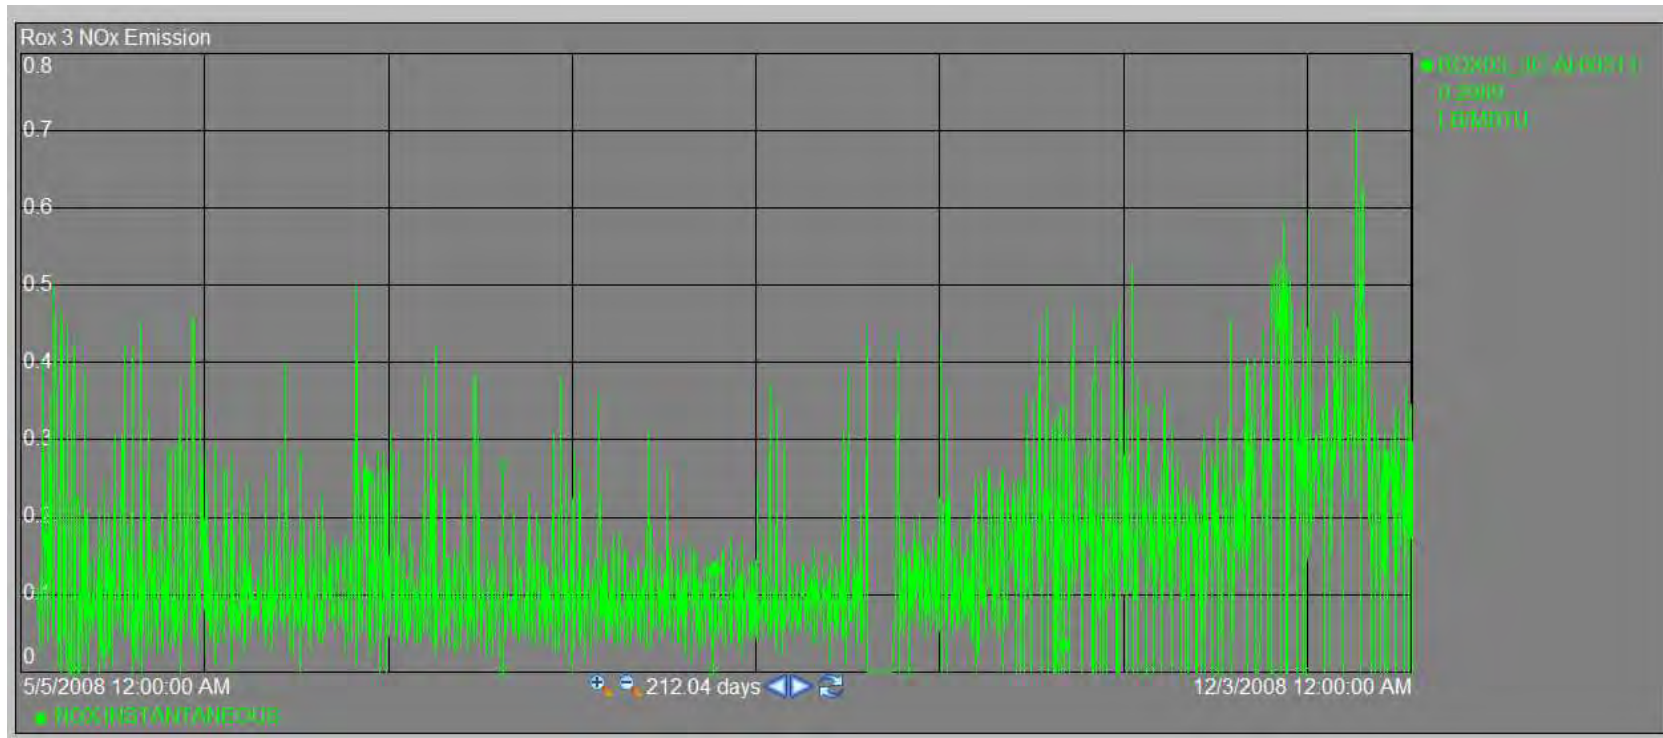
NOx emissions: May 2008 to December 2008

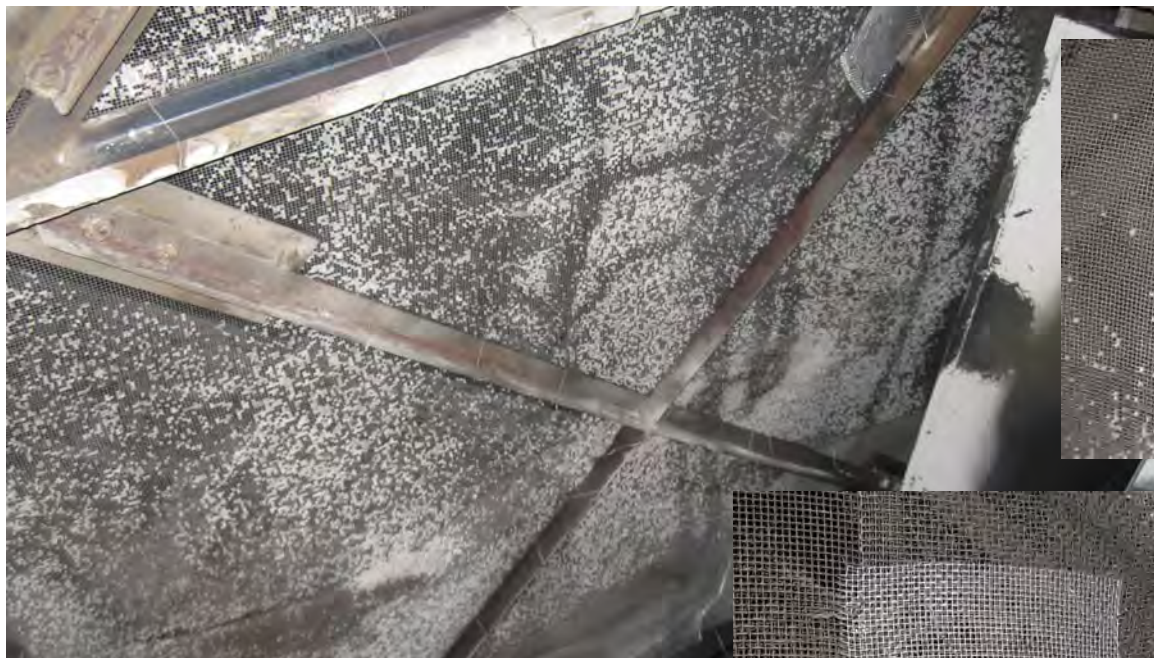
- LPA screen at economizer hopper plugs with ash over time
- Screen erosion also evident; periodic patching required

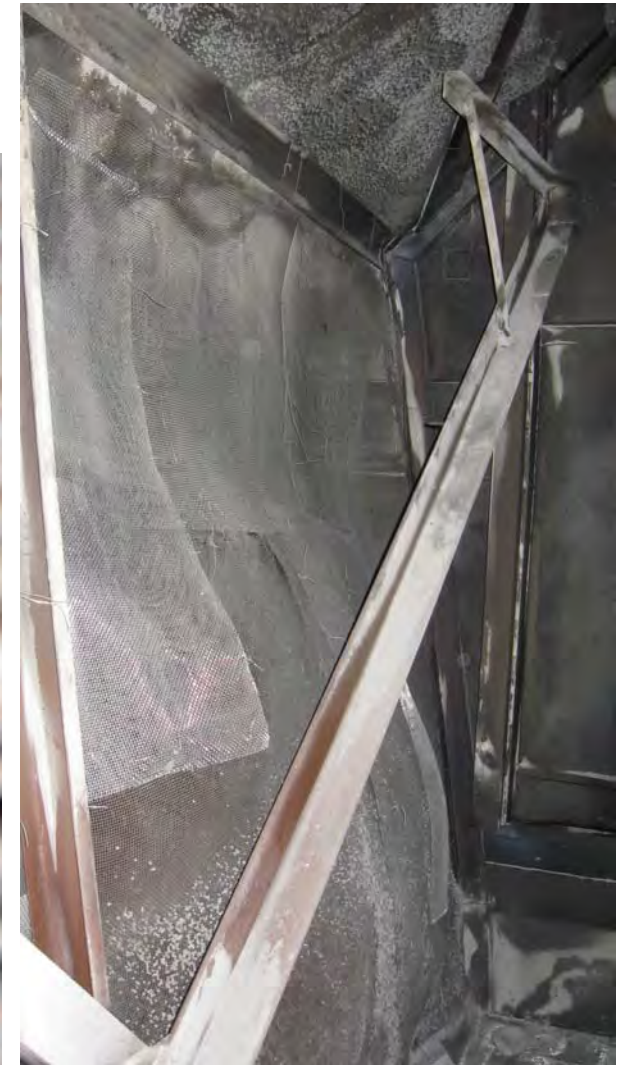
- LPA Screen
 - Pluggage and erosion primarily in SH passes
 - RH pass fairly clean and notably less erosion
 - Pluggage of upper screen estimated at 60% blocked
 - Combination of LPA and fine ash
 - Some evidence of moist ash
 - Lower screen slight pluggage near bottom, LPA wedged into screen openings
 - Erosion of SH pass lower screen is most pronounced
 - Erosion evident on floor section near hopper grating
 - Observed that it is difficult to patch screen completely

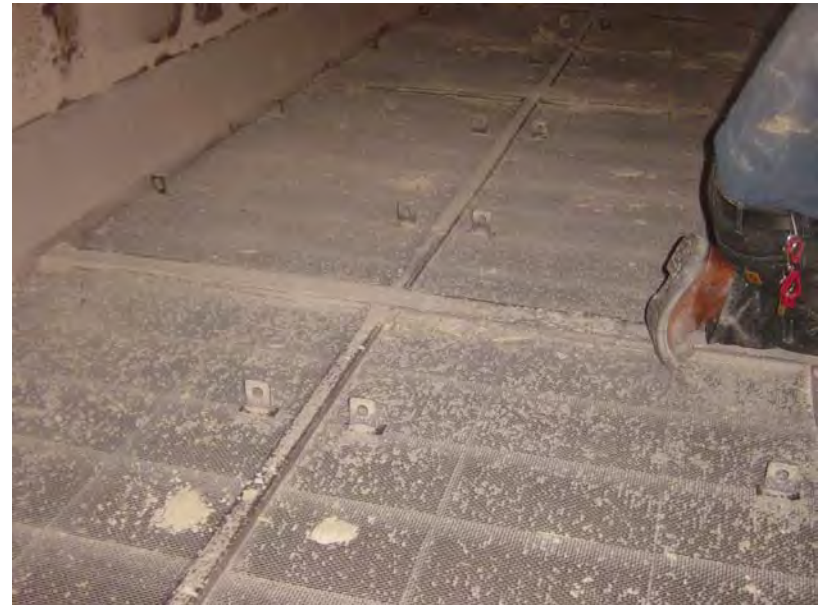
North wall LPA

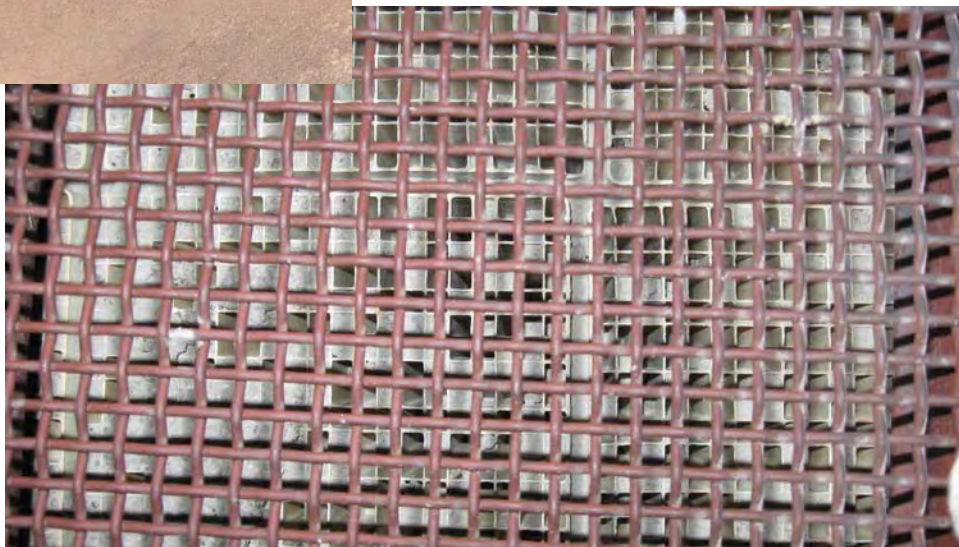
- SCR Reactors
 - Catalyst layer 1 empty
 - Large ash dunes on top of layers 2 and 3 starting from South wall (closest to boiler)
 - After vacuuming dunes, LPA and fine ash still present in catalyst channels
 - LPA present near North wall also
 - Fine ash build up noted on all trusses above catalyst, including monorail beams, empty first layer trusses, and rectifier supports
 - Fine ash build up on SCR inlet turning vanes (2-3 “ deep)

After
vacuuming

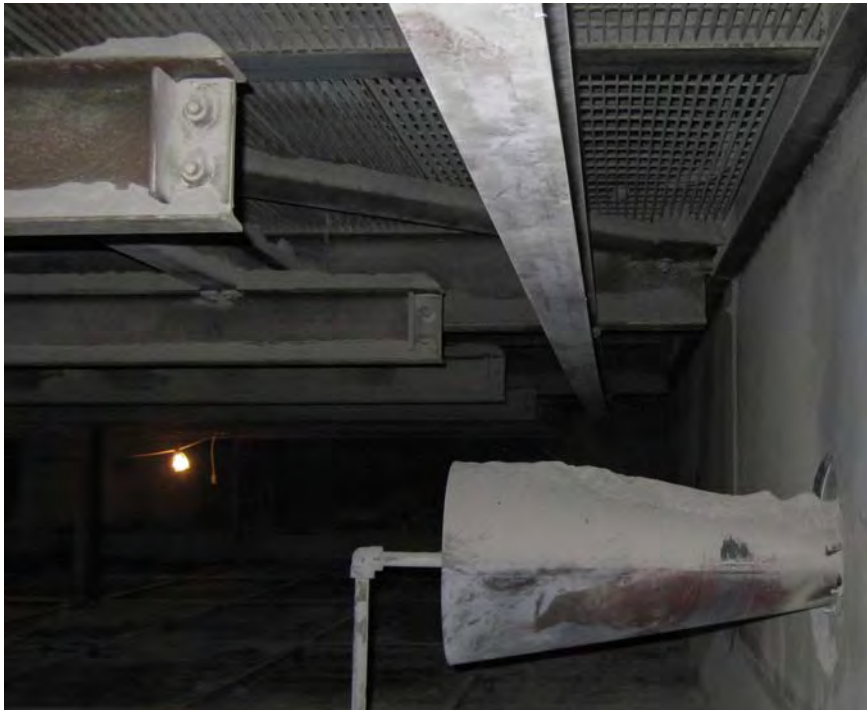
Monorail beams and trusses

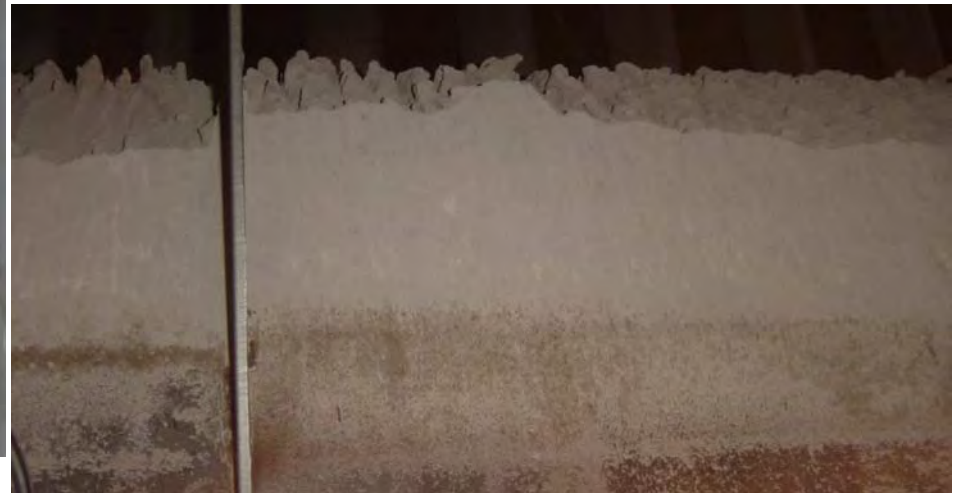
Reactor inlet turning vanes

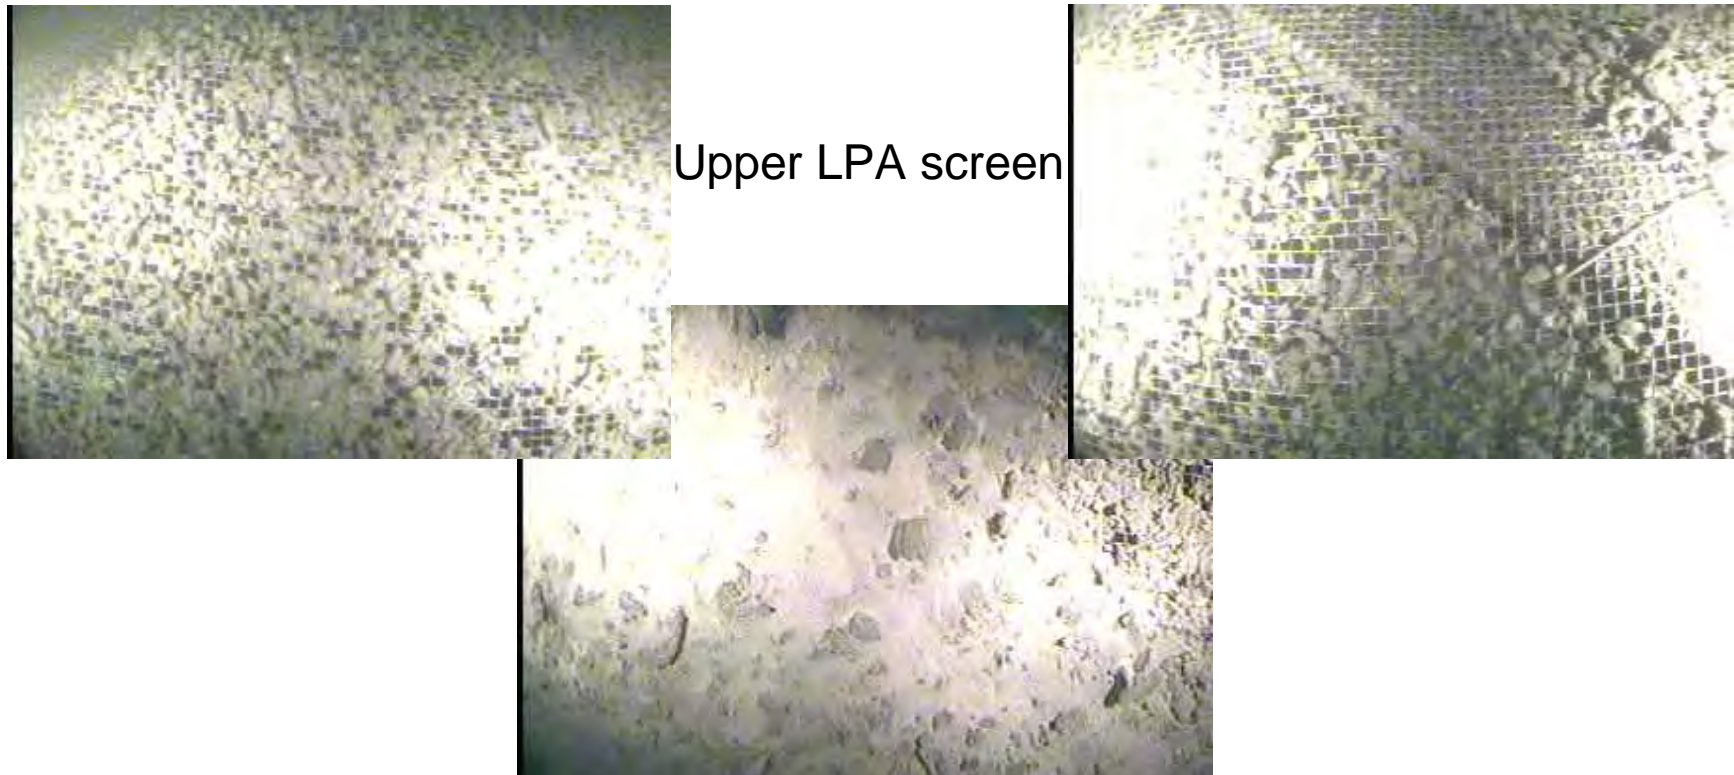
- Upper screen blockage estimated at 80-90%
- Lower screen only minor blockage noted

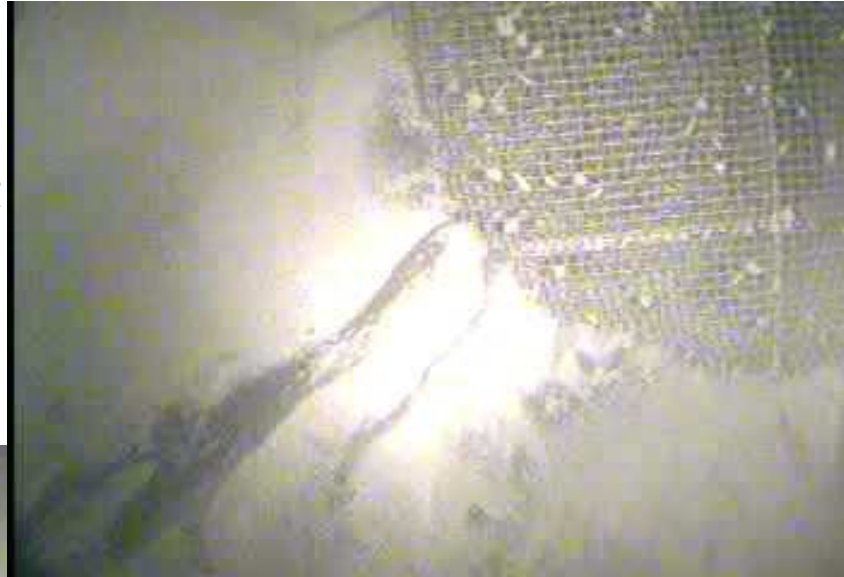
Along N-S ~6" wide module seal

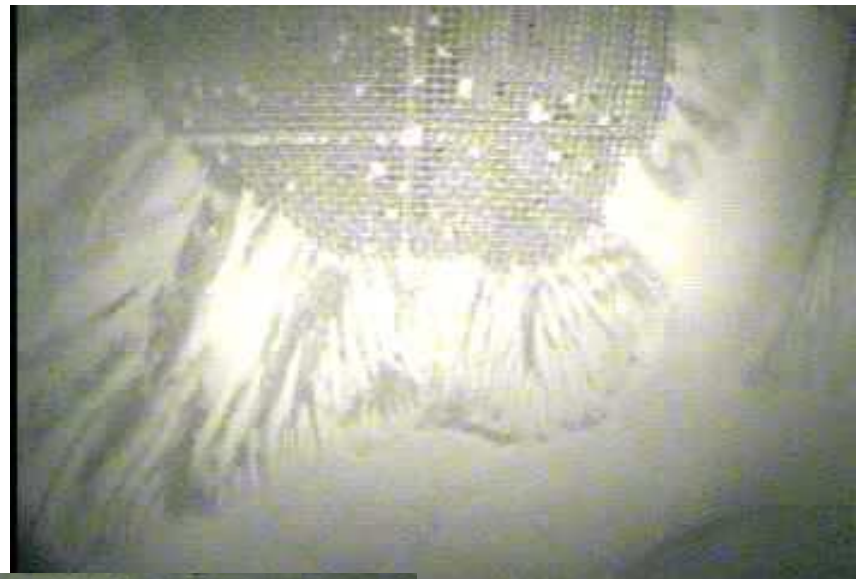
At some locations, ash extends over entire first module along seals

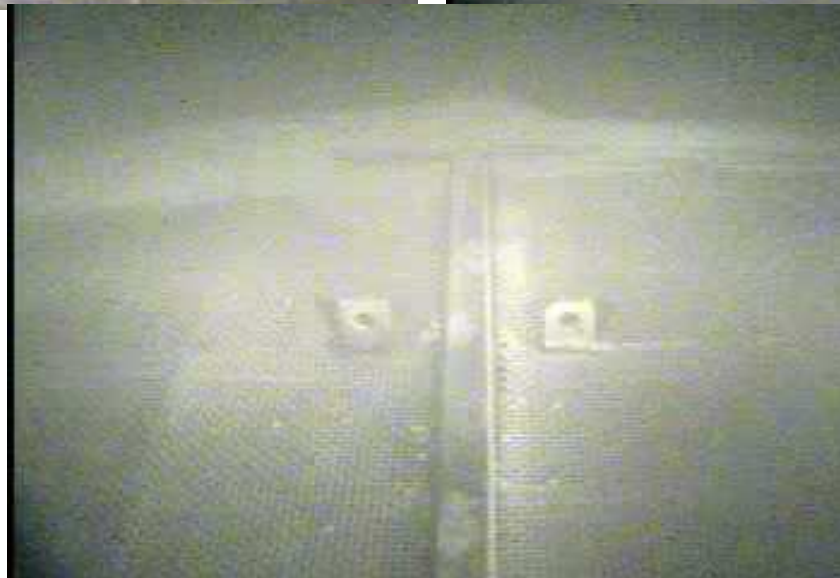
More bridging initiated along seals

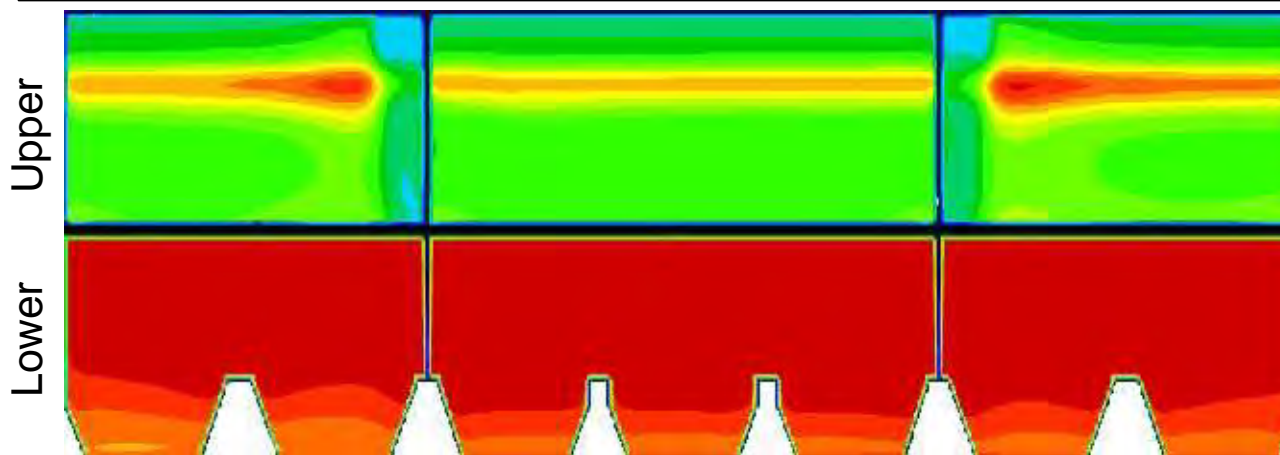
60% plugged upper screen

Avg Vel Upper = 29 ft/s

Avg Vel Lower = 67 ft/s

% area > 60 ft/s = 35%

Peak velocity 90 ft/s

DP increase 0.8 in.H₂O

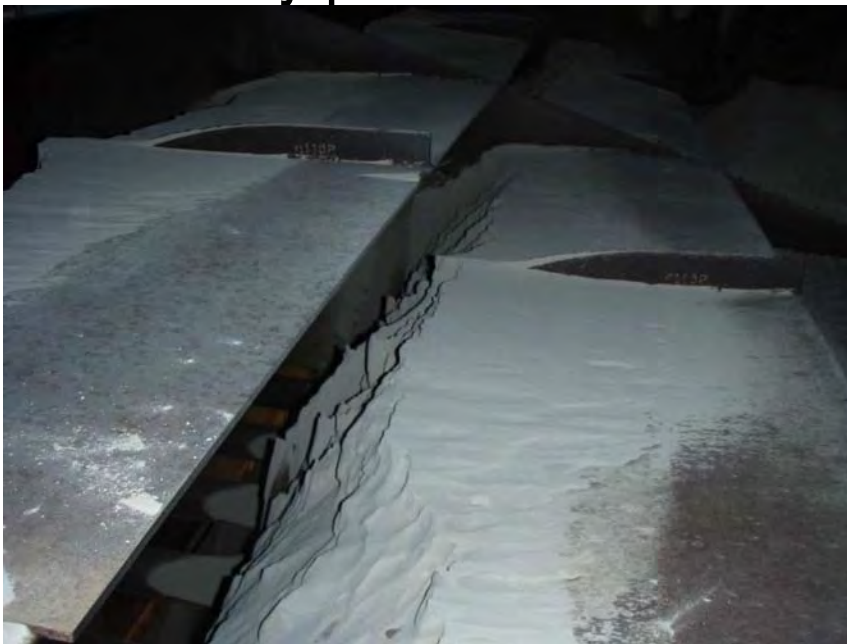
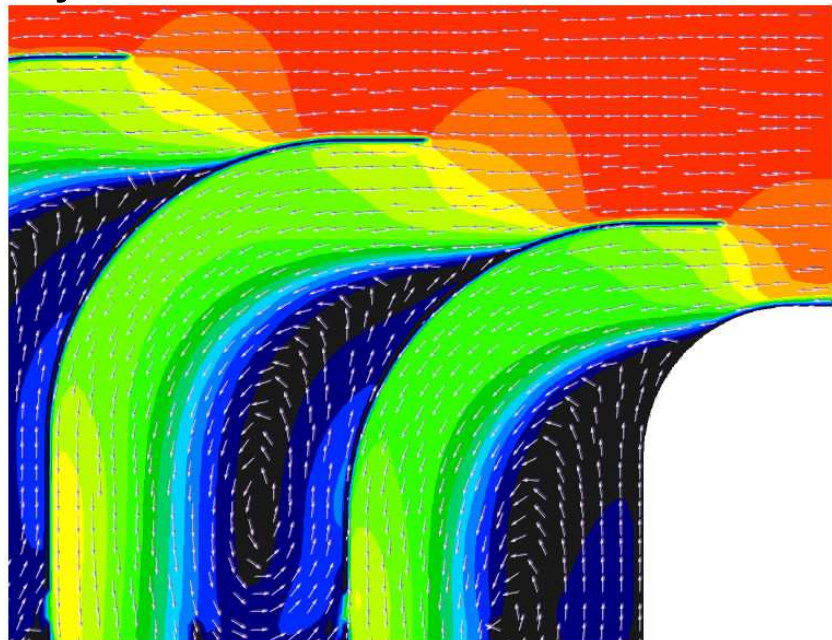
- Ash buildup on vanes occurs in flow recirculation zones above horizontal and curved vane surface
- Goal: Reduce size of recirculation zone without degrading velocity pattern at face of catalyst

- Revised Vane Geometry – 2 inch slot at strategic location

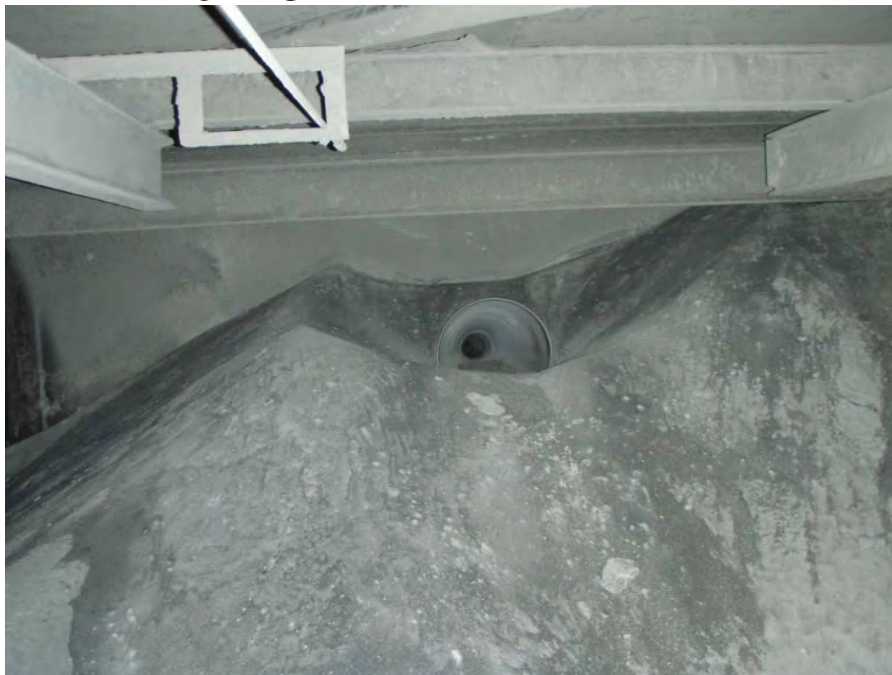
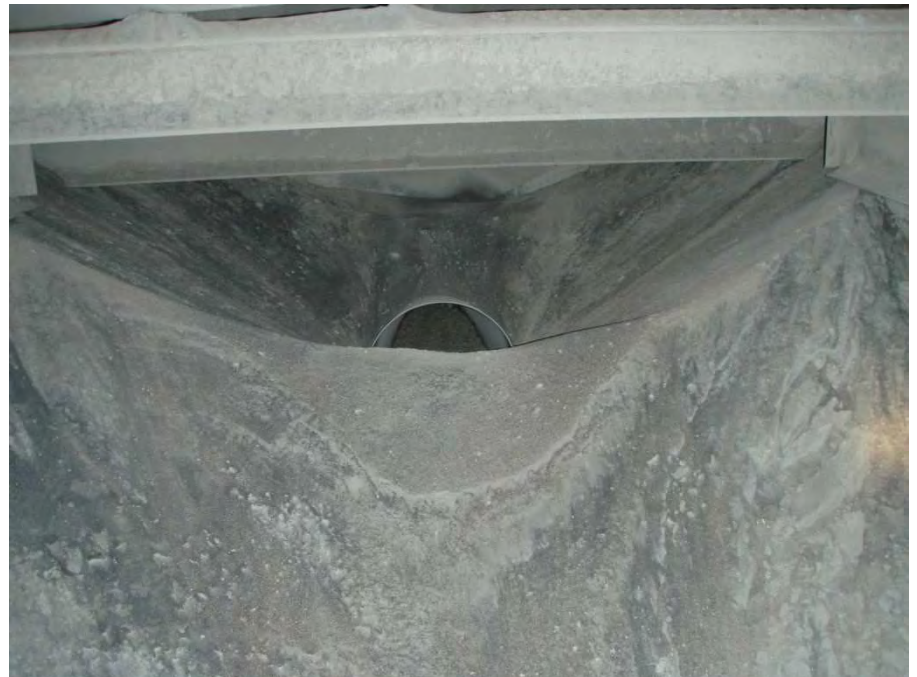
- Sonic horns have been effective in applications with little popcorn ash and sufficient flow conditions at low load.
- Ash loading in the Rox 3 SCR overwhelmed the sonic horns.

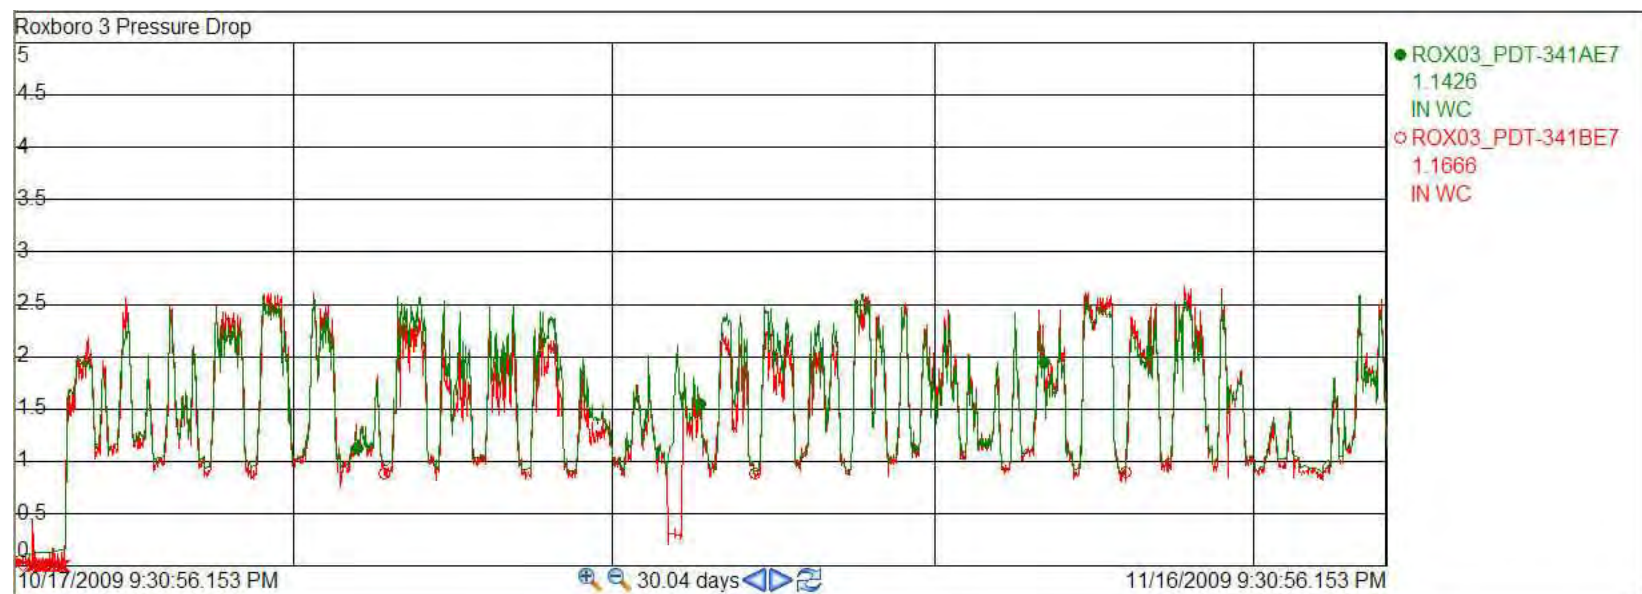
Reactor DP holding steady after 5 weeks operation
