Temperature Mixing Solutions

Case Study

By Robert G. Mudry, P.E.
Airflow Sciences Corporation

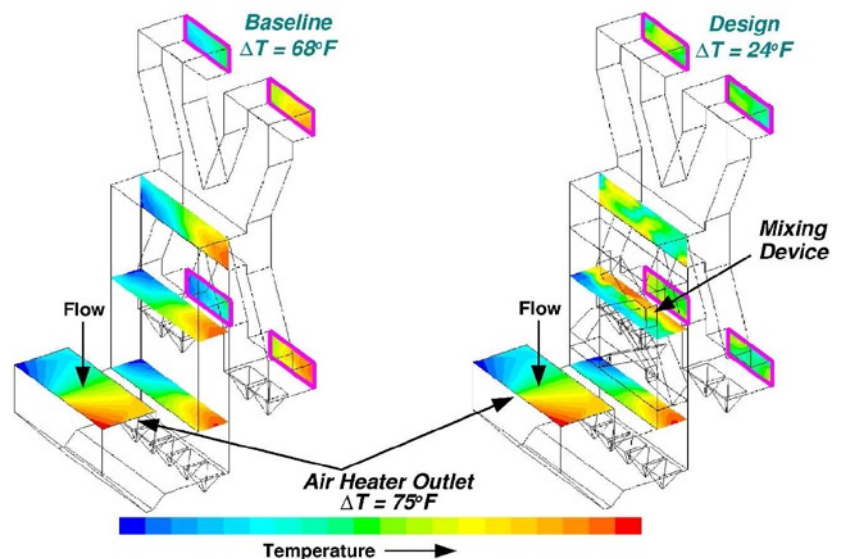
The duct geometry is shown in the figure. The flow exits the rotary air heater and splits to four separate ESP chambers (pink). Rotary air heaters typically cause a temperature gradient, and at Big Bend it was severe. Field testing indicated that the temperature varies by 75°F at the air heater outlet.

As the gas continues to the four ESPs, it does not mix much, due to the ductwork geometry and short residence time. The figure indicates the gas temperature profile at select planes within the duct. At the ESP inlet, the temperature variation is 68°F.

The CFD model was then used to develop a customized thermal mixer. A unique arrangement of baffles was developed to blend the hottest and coldest zones. After installation at Big Bend Unit 2, the temperature gradient was reduced to 24°F. The added pressure loss was 0.7 IWC, well within the plant-specified maximum of 2.5 IWC.
