# SCR Catalyst Pluggage Reduction at Progress Energy's Roxboro Station

Paper # 173

Matt Boone  
Progress Energy

Robert Mudry, P.E.  
Airflow Sciences Corporation, 12190 Hubbard Rd., Livonia, MI 48150

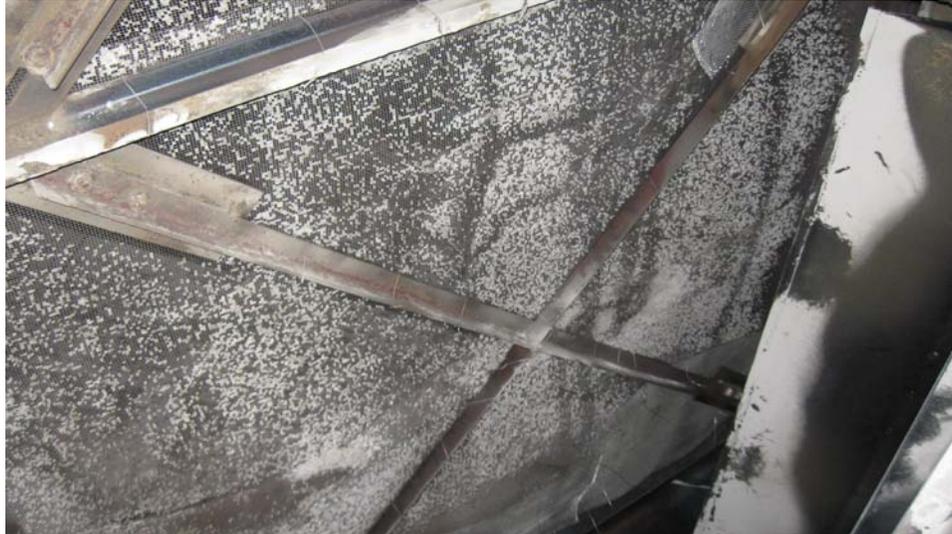
Figure 5. LPA Screen Pluggage, May 2009

The May 2009 inspection revealed that the upper section of the screen was plugged with a combination of LPA and fine ash. It is theorized that the angle of the upper screen is not steep enough for LPA to slide down it via gravity. Erosion of the lower screen was observed in a

number of locations, especially near the beams of the screen framework and on the floor near the hopper grating. Both pluggage and erosion were most pronounced in the SH passes; the RH passes showed only slight evidence of damage. Repairs to the lower screen were being made during the inspection, and it was observed that it is difficult to patch the screen completely, increasing the risk that LPA could slip past the screen. Figure 5 shows the condition of the upper LPA screen immediately after shutdown for the May 2009 outage. It was estimated that roughly 60% of the upper screen was blocked by ash.

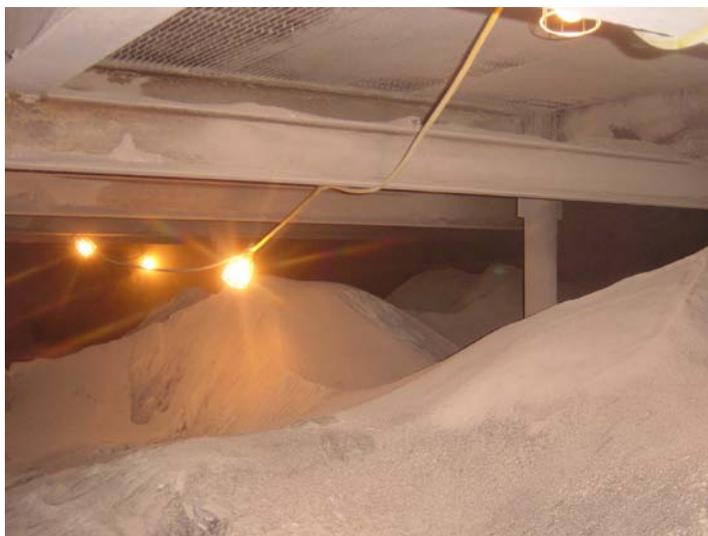
Figure 6. Typical Ash Accumulation on Catalyst Layers Before Vacuuming

At the time of the inspection, Layer 1 of the SCRs was empty. Layers 2 and 3 contained large dunes of ash several feet in height, starting from the south wall (closest to the boiler) and extending across approximately 50% of the cross-sectional area. The ash accumulation is shown in Figure 6.

Ash build-up was noted on all trusses above the catalyst, including monorail beams, empty first layer trusses, and rectifier support beams. Ash build-up was also observed on several of the SCR inlet turning vanes upstream of the rectifier.

During the outage, the catalyst layers were vacuumed and cleaned. The cleaning process took nearly 3 days. After the ash was vacuumed off the surface of the layers, LPA and fine ash were still present in the channels of the catalyst layers. The photo of Figure 7 shows this situation.

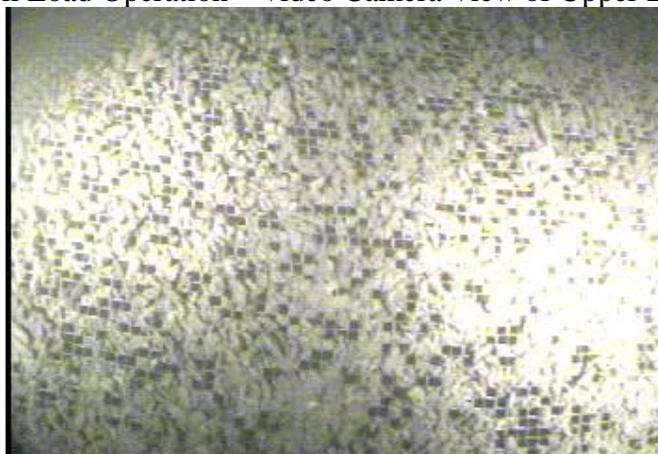
Figure 8. Full Load Operation – Video Camera View of Upper LPA Screen

In addition to the velocity testing, a high-temperature video camera was inserted into the ports to examine the LPA screen and catalyst layers. At the LPA screen, it was observed that the upper screen was more plugged with particles than when the unit was off-line. Blockage was estimated at 80-90% compared to ~60% with no gas flow. This is shown in the image of Figure 8. At the lower screen, a small amount of blockage was noted. Long-duration testing allowed the observation of several LPA particles in transit as they fell out of the gas stream onto the screen.

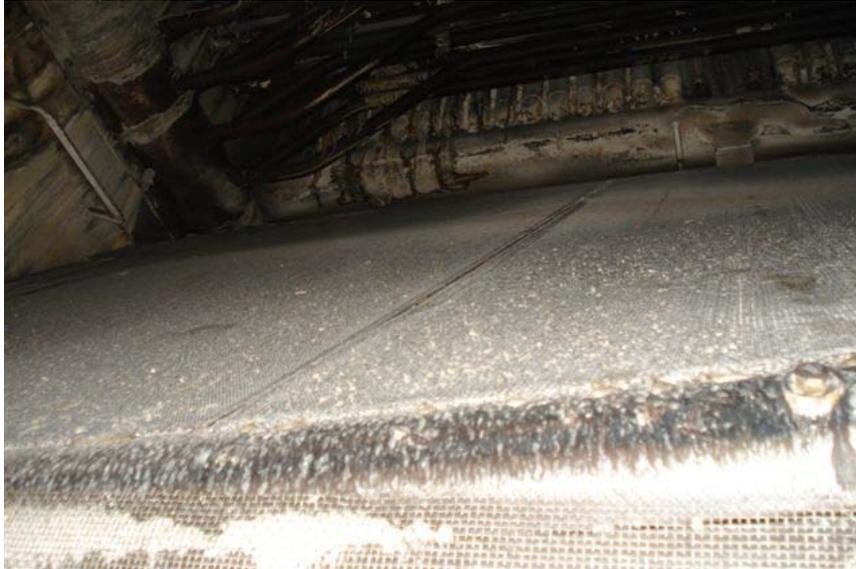
Figure 13. Upper LPA Screen Condition, May 24, 2010

- “Screens looked good, no dust in vertical screens, top plate has some holes plugged but it is a lot better than the old screens.” A photo of the screen is shown in Figure 13.

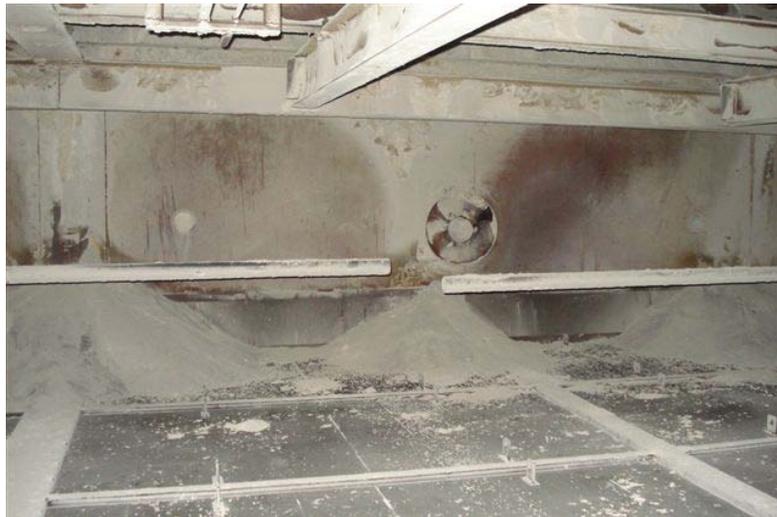
Figure 14. Reactor 3A Top Catalyst Layer Condition, May 24, 2010

- “3A SCR looked good. A few piles along the south wall, approx. 1/2 row out. Small piles were on top of catalyst screens but clean under. It didn't take much to move the piles on thru the catalyst.” This is shown in Figure 14.

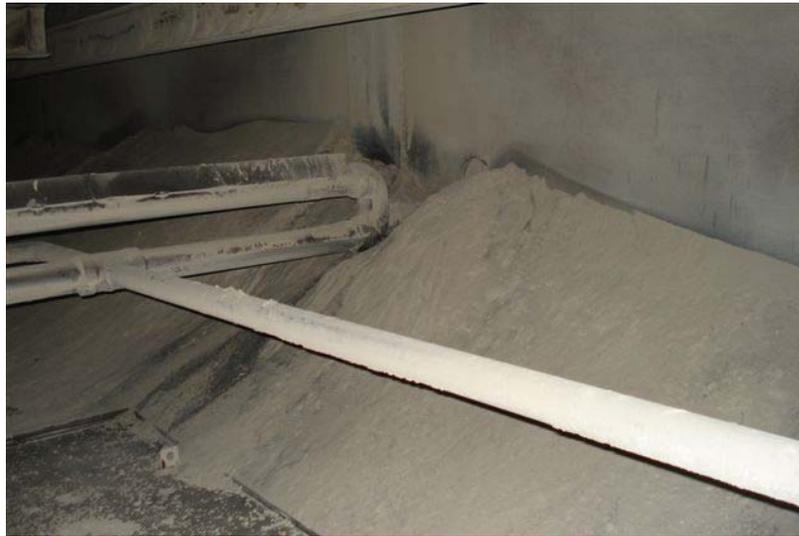
Figure 15. Reactor 3B Top Catalyst Layer Condition, May 24, 2010

- “3B SCR had a dust pile on the south wall, covering 1 row and up about 24" on the wall.” This is shown in Figure 15.

- “There were some small piles around on top of the screens, but the catalyst was clean under the piles. It did not take much to move the dust thru the screen and thru the catalyst. I noticed in 'B' SCR that there was a lot of dust falling from the beams and overhead that I didn't notice in 'A'. This dust would fall and sit on top of the screens until I disturbed it. Maybe this occurred during shutdown.”
