Catalyst Pluggage Reduction for Roxboro U3

- Matt Boone – Progress Energy
- Rob Mudry – Airflow Sciences

- November 17, 2009

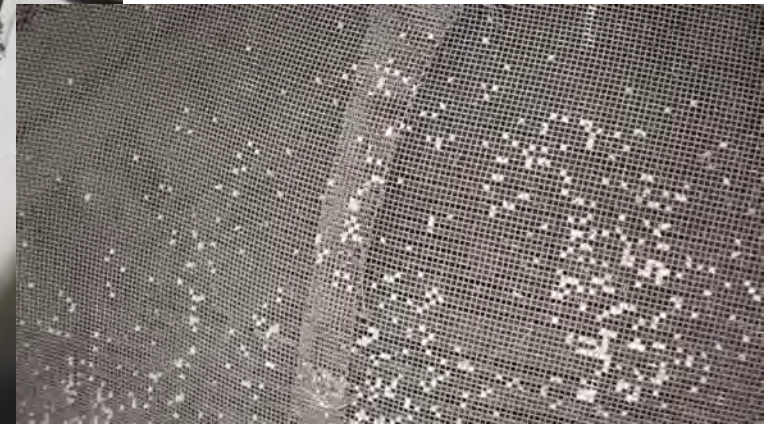
Lower screen

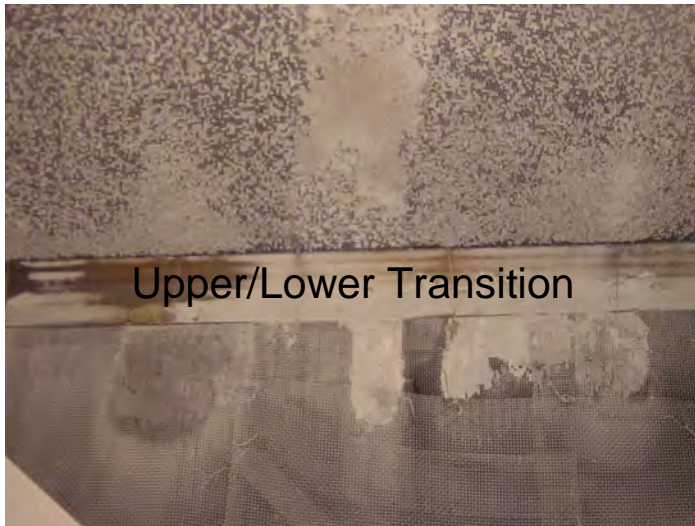
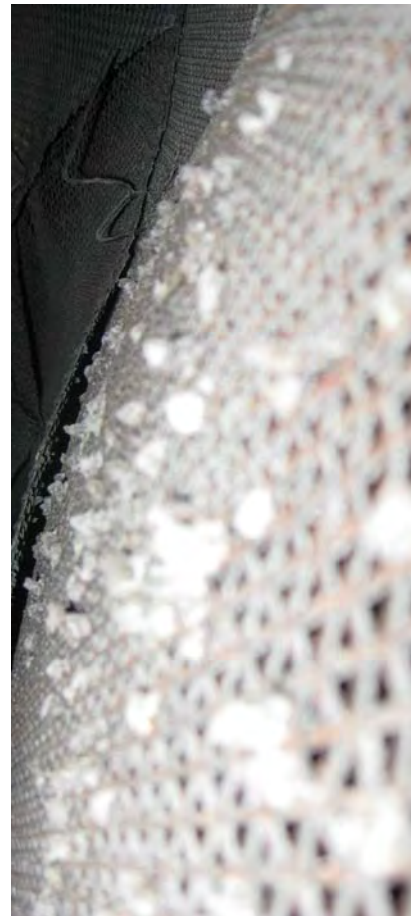
- LPA Screen
 - Pluggage and erosion primarily in SH passes
 - RH pass fairly clean and notably less erosion
 - Pluggage of upper screen estimated at 60% blocked
 - Combination of LPA and fine ash
 - Some evidence of moist ash
 - Lower screen slight pluggage near bottom, LPA wedged into screen openings
 - Erosion of SH pass lower screen is most pronounced
 - Erosion evident on floor section near hopper grating
 - Observed that it is difficult to patch screen completely

Lower Screen

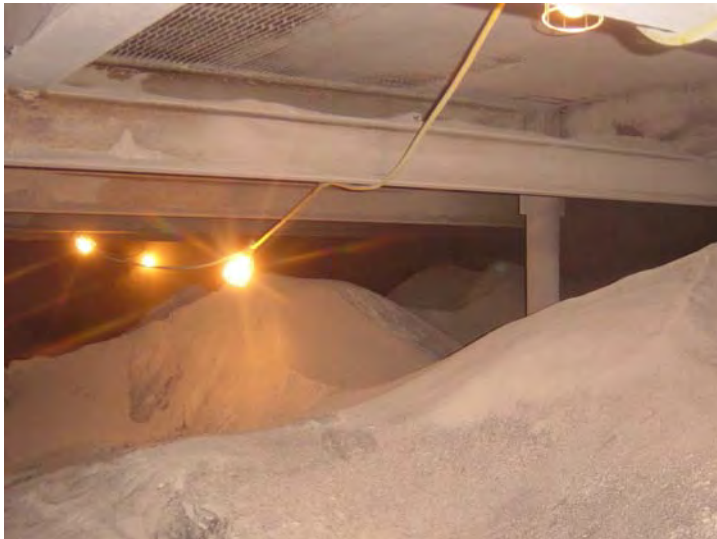
- SCR Reactors
 - Catalyst layer 1 empty
 - Large ash dunes on top of layers 2 and 3 starting from South wall (closest to boiler)
 - After vacuuming dunes, LPA and fine ash still present in catalyst channels
 - LPA present near North wall also
 - Fine ash build up noted on all trusses above catalyst, including monorail beams, empty first layer trusses, and rectifier supports
 - Fine ash build up on SCR inlet turning vanes (2-3 “ deep)

Before
vacuuming

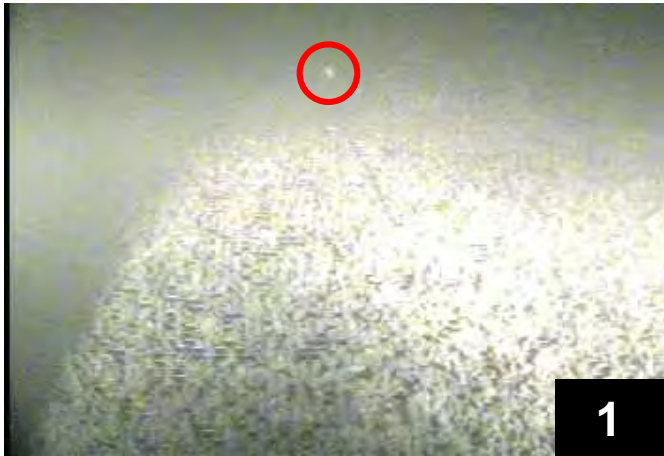
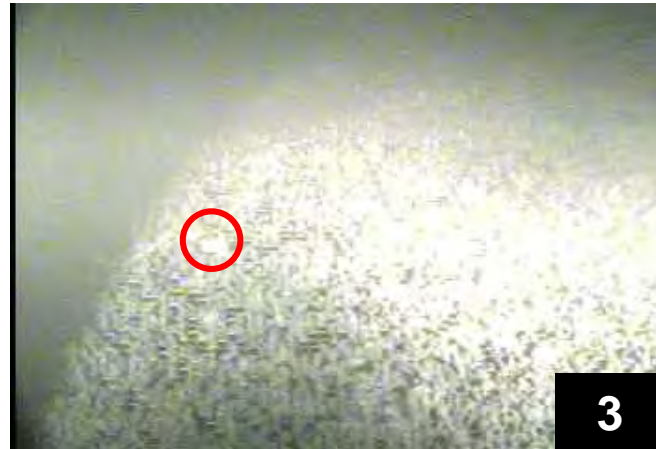
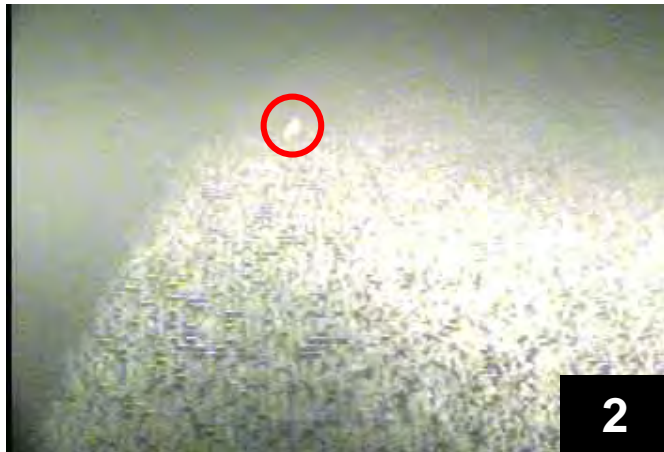
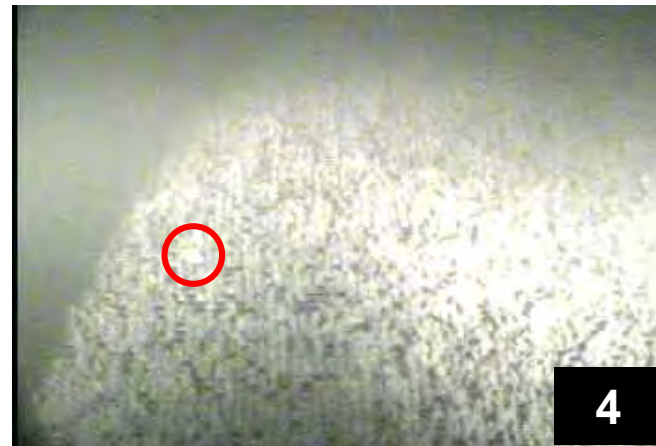
- Tracking an LPA particle to the upper screen

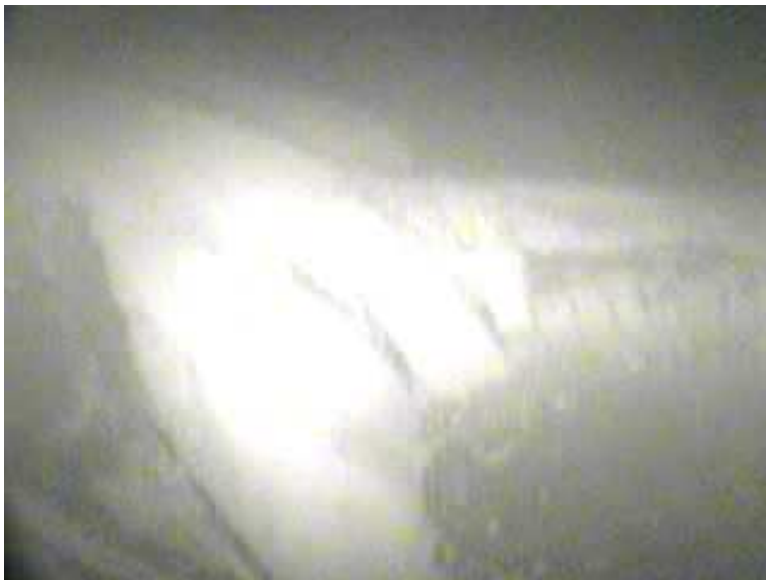
Along south wall, ash
extends 1-2' from wall

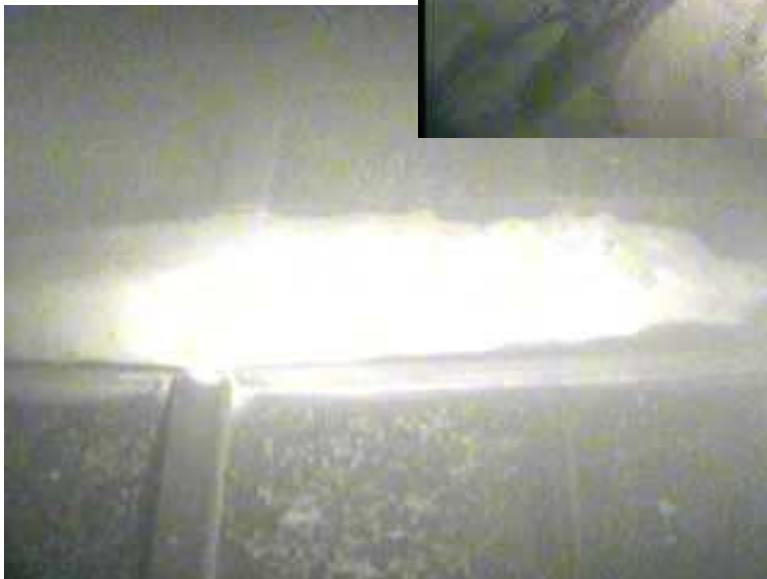
Along N-S ~6" wide module seal

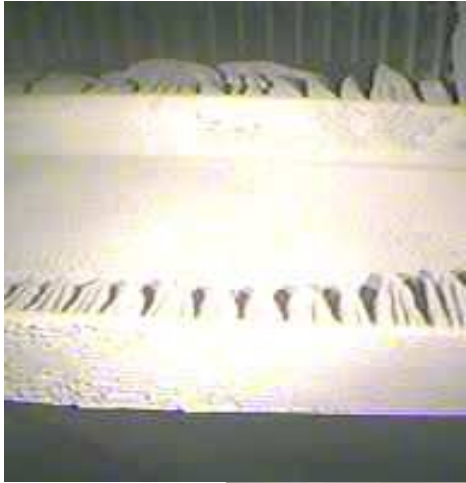
Ash build up on
reactor trusswork

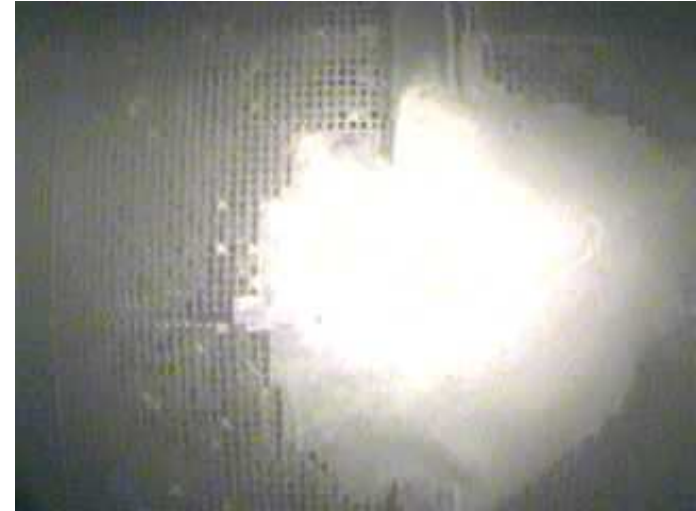
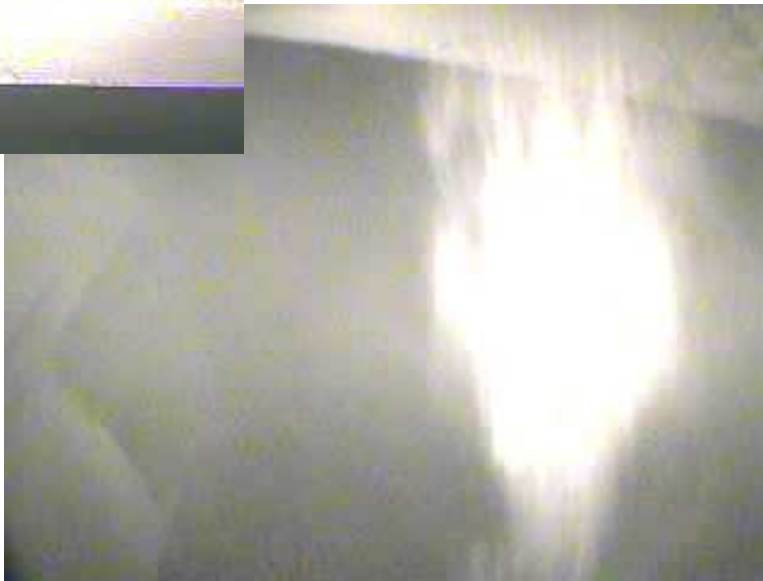
Ash avalanche event
captured on video. No sonic
horns in operation.

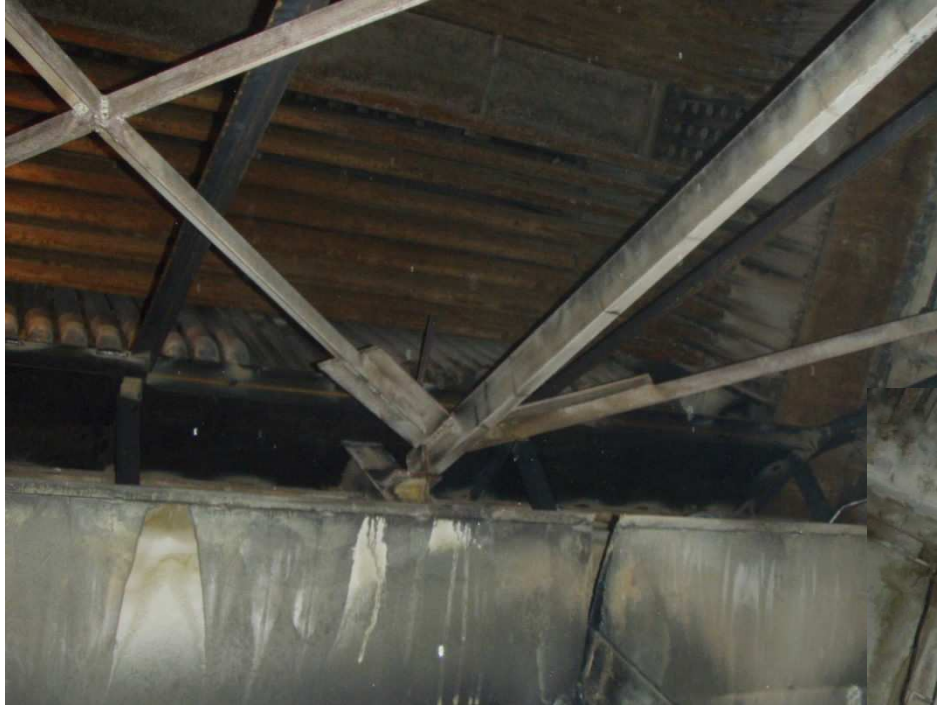
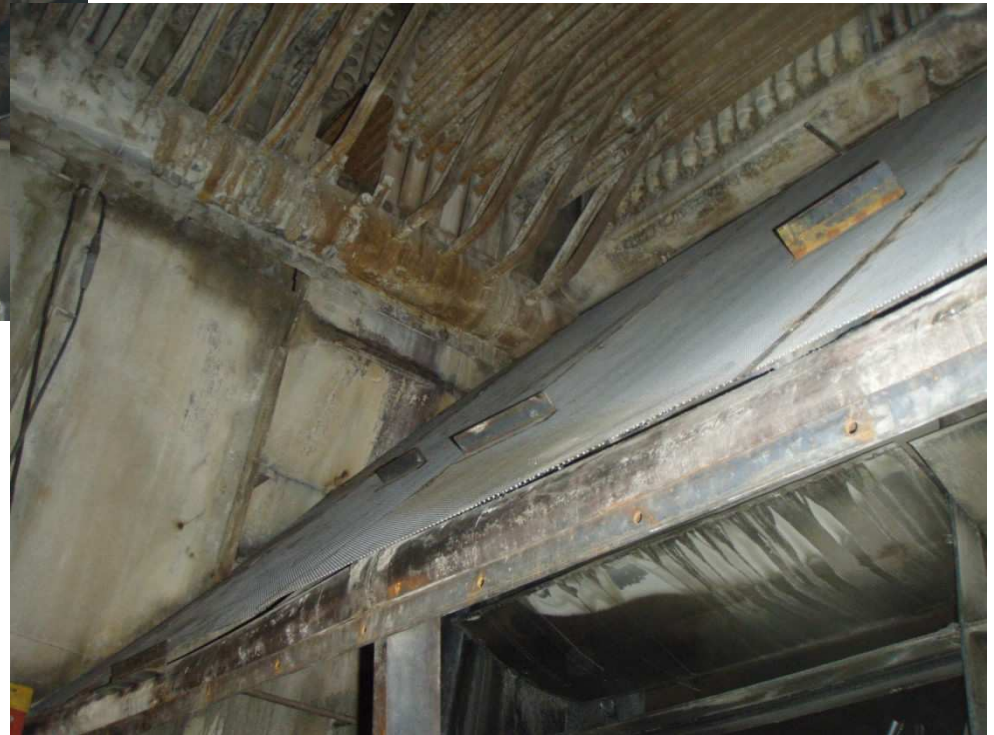
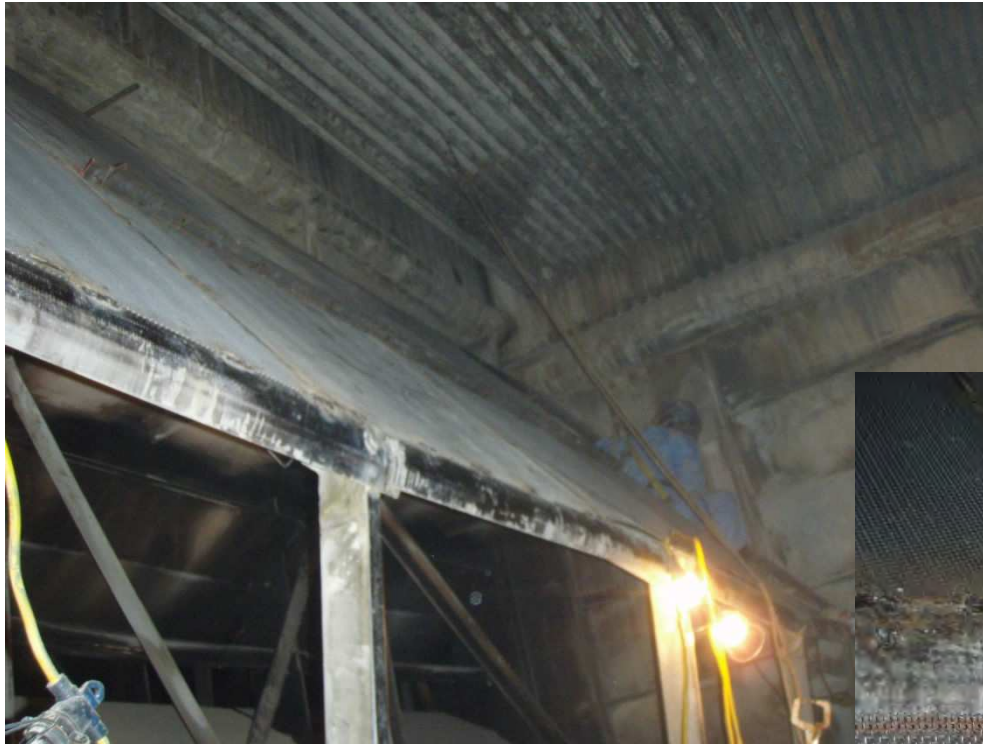
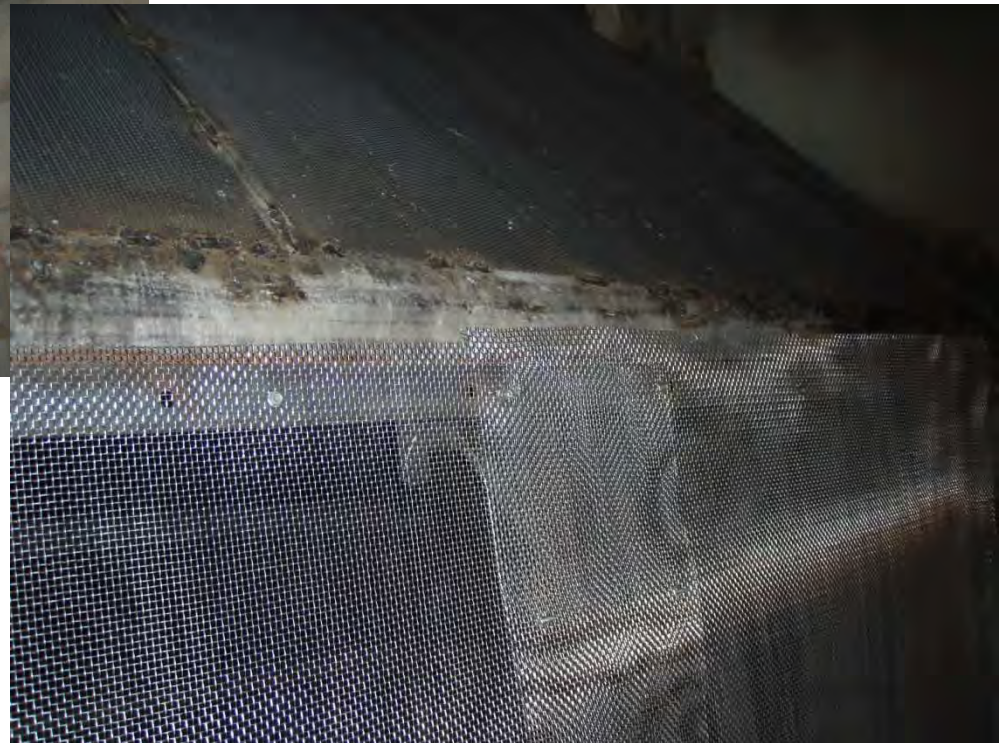
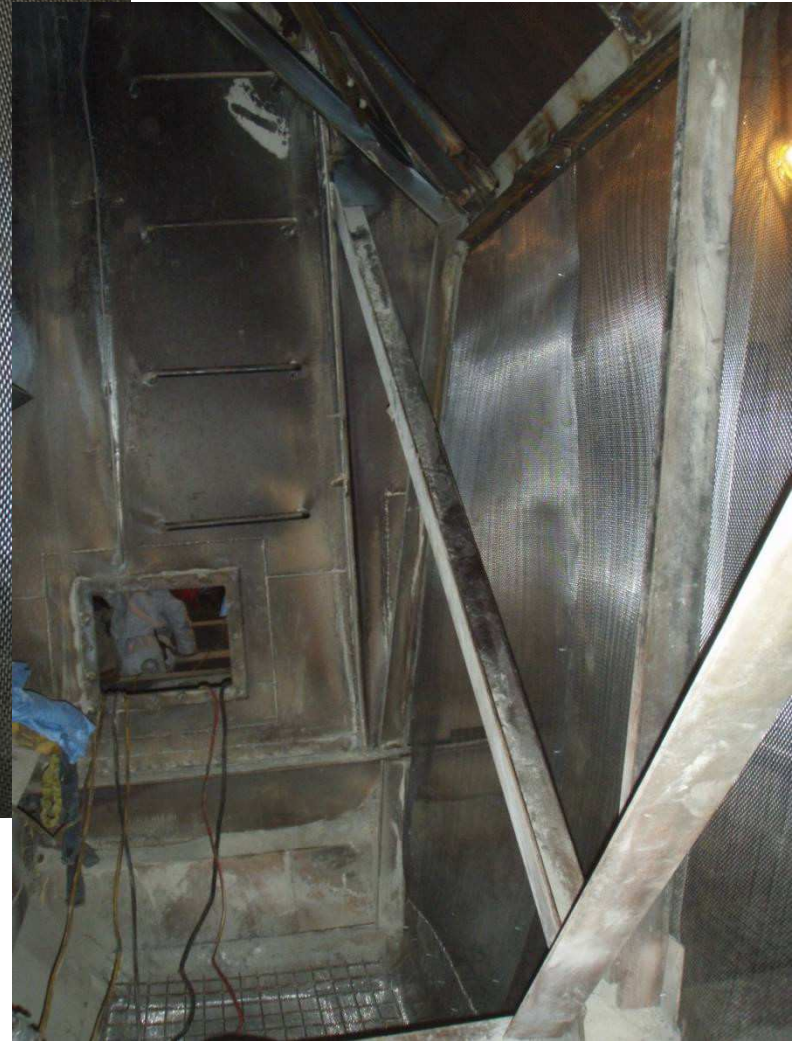
LPA screen installation

- Upper screen blockage estimated at 80-90%
- Lower screen only minor blockage noted

- Combination of CFD modeling and field testing used to analyze root causes of catalyst pluggage
- CFD modeling used to develop new design for LPA screen and reactor inlet vanes
- New sootblowers installed at all layers
- Catalyst pluggage situation appears to be under control based on observations after 4 weeks operation
 - No evidence of ash accumulation on catalyst
 - Will continue to monitor performance over time
- LPA screen upper section still showing pluggage; less than previous
 - Steeper angle or upper deflection baffles may be required to eliminate pluggage
 - Will continue to monitor over time to determine if design revisions are necessary

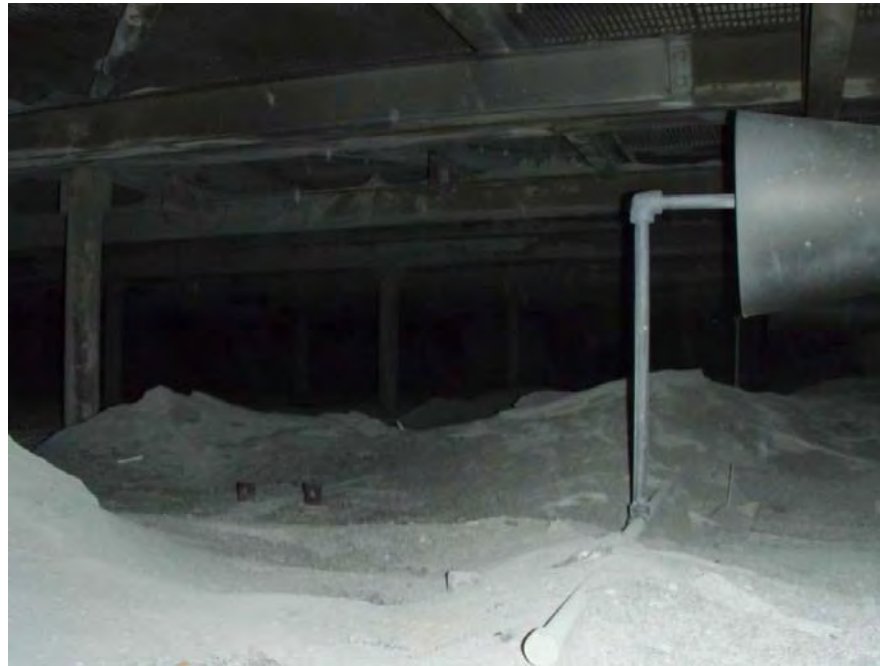
Ash lance effectiveness

- Plant-manufactured ash lances were installed in December 2008.
- The lances controlled the extent of the ash pile and shortened time needed to vacuum the SCR.
